The Influence of Surface Enhancement by Low Plasticity Burnishing on the Corrosion Fatigue Performance of AA7075-T6

Paul S. Prev  y (pprevey@lambda-research.com)
Lambda Research, 5521 Fair Lane, Cincinnati, Ohio 45227

John T. Cammett (cammettjt@navair.navy.mil)
Naval Aviation Depot, PSC Box 8021, MCAS Cherry Point, NC 28533

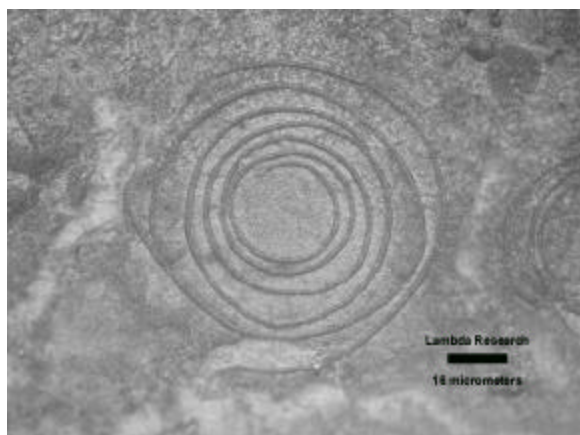
Figure 4 – Spiral oxidation patterns at the edge of an LPB 7075-T6 surface after 100 hr. salt fog exposure.

Corrosion damage was documented both in terms of the nature of the oxide layer formed and the depth of pits. Surface oxidation was examined by optical microscopy with both low and high magnifications. Pit depths and distributions were measured at high magnification using the calibrated fine focusing adjustment on a Zeiss Universal optical microscope after removal of the surface layer of oxide corrosion product with nitric acid. Macroscopic and fractographic examination of the exposed surfaces revealed that 100-hr. salt fog exposure of the machined surface resulted in pitting corrosion distributed uniformly over the test surfaces. Typical pit depths were 100 μm to 120 μm (0.004 to 0.005 in.). After penetration of the surface, the corrosion crevices often were observed to progress laterally, thereby delaminating layers of material and apparently following the elongated grain boundaries produced during rolling of the plate. Salt fog exposure for 100 hr. after LPB produced a different pattern of oxidation. Predominantly, circular patterns were observed in the surface oxide at higher magnification, as shown in Figure 3. Striking spiral patterns were observed at the edges of the exposed surface, as shown in Figure 4. Shallower pitting was observed on the

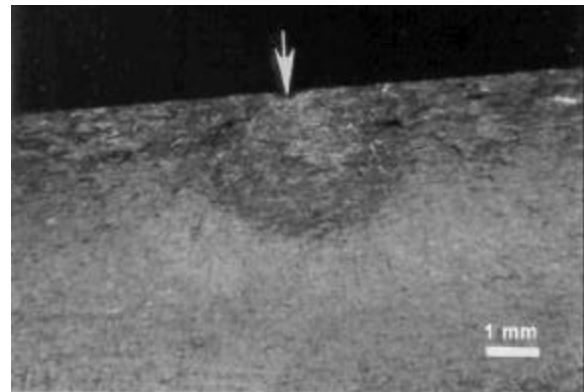
Figure 9 – Fatigue fracture surface of typical machined + 100hr salt fog exposure sample. Arrow indicates fatigue origin at the site of corrosion pit.
